VISUAL BUILDING INSPECTION REPORT

Exclusively for : Compass Building & Pest Inspections

Brisbane

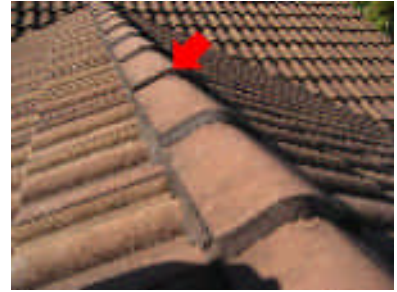
The overall condition of the roof coverings is fair. The mortar bed to the ridge capping is cracked and requires re bedding and pointing. A small number of cracked roof tiles were noted and should be replaced. Tile roof requires a service/ maintenance, re point capping tiles, replace cracked tiles and maintenance to flashings.

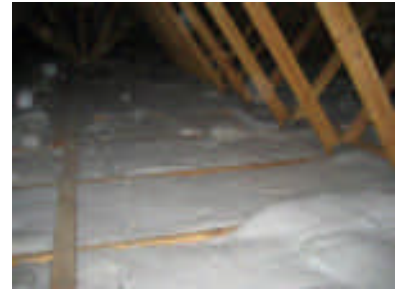
Insulation is present to roof cavity.

No Sarking is present to roof cavity.

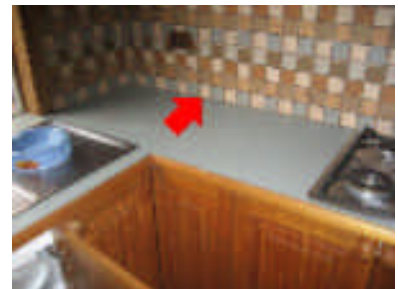
Replace/ install sealant to join between bench tops and splashbacks to prevent moisture penetration. The condition of the tiles is generally fair.

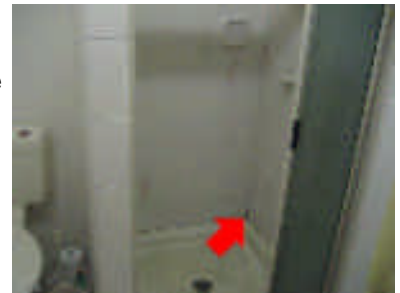
Shower and Bath appears to be in a serviceable condition. Replace/install sealants to internal corner and around base of shower.

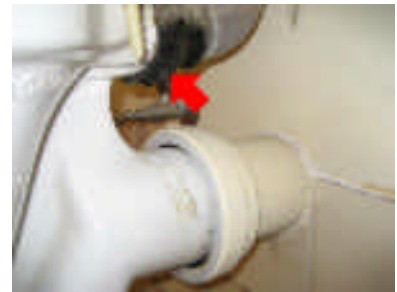
General condition of area: This area is generally in good condition. No lift off hinges to door. Consideration should be given to install lift off hinges for safety/emergency reasons.

Toilet Condition: The toilet is in working order. Flush pipe rubber leaks. Requires replacement.

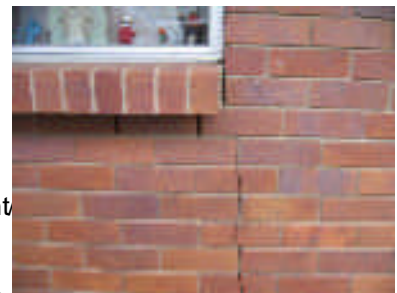
Condition: The condition of the walls is generally fair. Movement/ cracks are evident to brickwork. Visible movement/ cracking appears moderate. The area where cracked brickwork was noted is listed below. Movement/ cracks noted to areas of external brick walls indicates that settlement movement to structure has occurred. This possibly due to climatic conditions suffered by foundation soils, downpipe leaks, mature trees close to building or poor surface drainage. These items listed are known as conducive items that can cause movement to buildings. Reading this report in full can give you information on foundation maintenance, Monitoring of cracks is recommended. If changes occur of an excessive nature a suitably qualified structural engineer should be engaged to further investigate.

Position/ Location: Right hand side elevation, Rear elevation.
Weepholes: Keep brick weep holes clear of earth, concrete and vegetation as this provides an entry point for moisture to enter structural wall frames and undetected termite entry. Refer to Timber Pest Inspection Report.

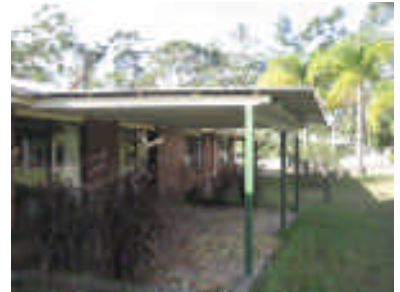
Position/ Location: Rear elevation.
Construction & Condition: Constructed from timber. The general condition of this structure is fair.

Defects or Maintenance Items: No Guttering or spouting installed. Minor wood decay is present to the structure.

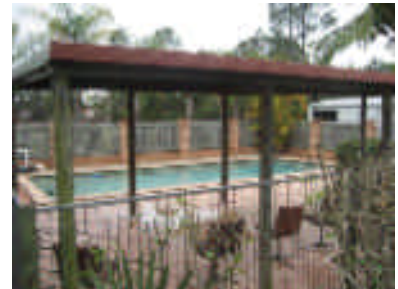
Pool Fencing: Loose pool fence panels as well fixings to fence panels missing. Repair/ maintenance is required as a matter Urgency, Safety Concerns
