VISUAL TIMBER PEST REPORT

Inspection Date: 2007

Prepared by Inspector: Peter Rachow

Brisbane

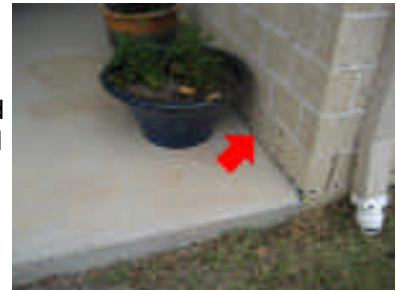
Slab areas

The external weep holes are very close to the ground level in some areas. This can allow concealed termite entry and we recommend that all weep holes be exposed and kept clear of soil, foliage, debris, stored items or other obstructions. Furthermore, these areas should be regularly inspected. Concrete patio slab has been installed post dwelling construction concealing physical termite barriers. Recommend contacting installer for further advice regarding comment. See Treatment recommendations for this inspectors opinion.

Drilling of external concrete patio adjacent to the foundation walls and the injection of a chemical termite control agent.

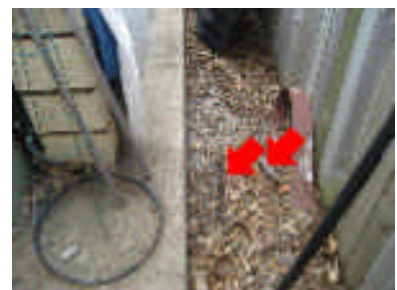
Rear section of the property:

Yes - Inspection revealed currently inactive termite attack (damaged timbers and/or termite workings) within this area including but not necessarily limited to the following timbers and the areas listed below.

Loose timbers on ground or in ground.

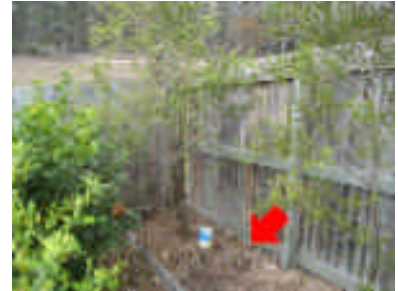
Yes - Inspection revealed currently active termites within this area including but not necessarily limited to the following timbers and the areas listed below.

Coptotermes spp.

Rear fence, timber onground under fence.:

We recommend the installation of a termite baiting and monitoring system at this property.
